Project Name: Cottonwood Wash Barriers

Project Number: 1586-5-2F

Disaster Name: February 2005 Winter Storm and Flood

Location: Town of Pima

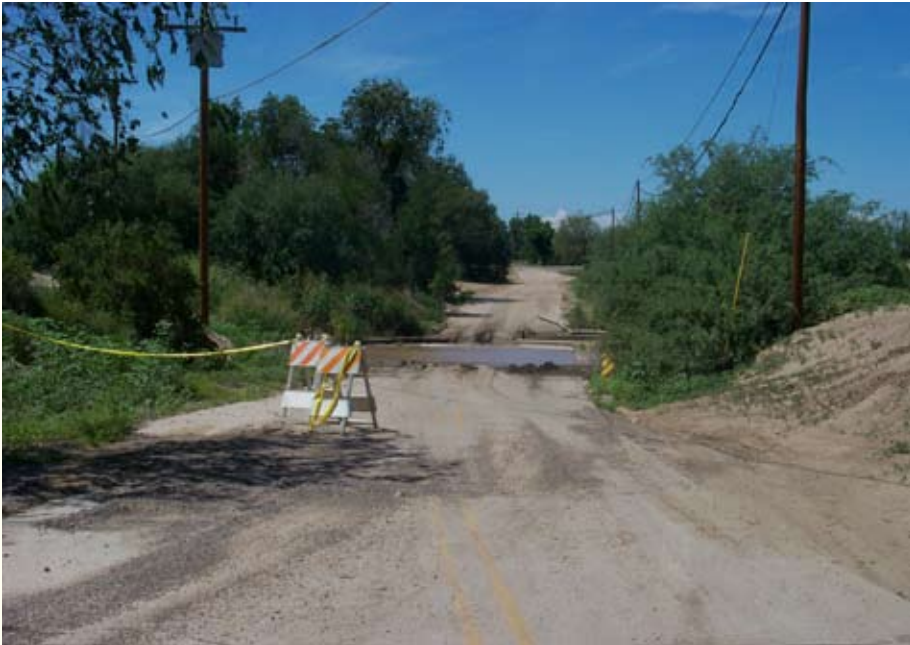
Before

The Town of Pima had a low-water crossing of Cottonwood Wash on 200 north. The crossing has 2 – 12" culverts underneath the concrete to handle small amounts of water. During large amounts of water including floods the Town barricades and ribbon tapes the crossing to keep motorists from crossing. The Town had built two (2) swing gates that could be closed during floods. The gates would make it where the Town would not have to have a police vehicle parked at this location for access control.

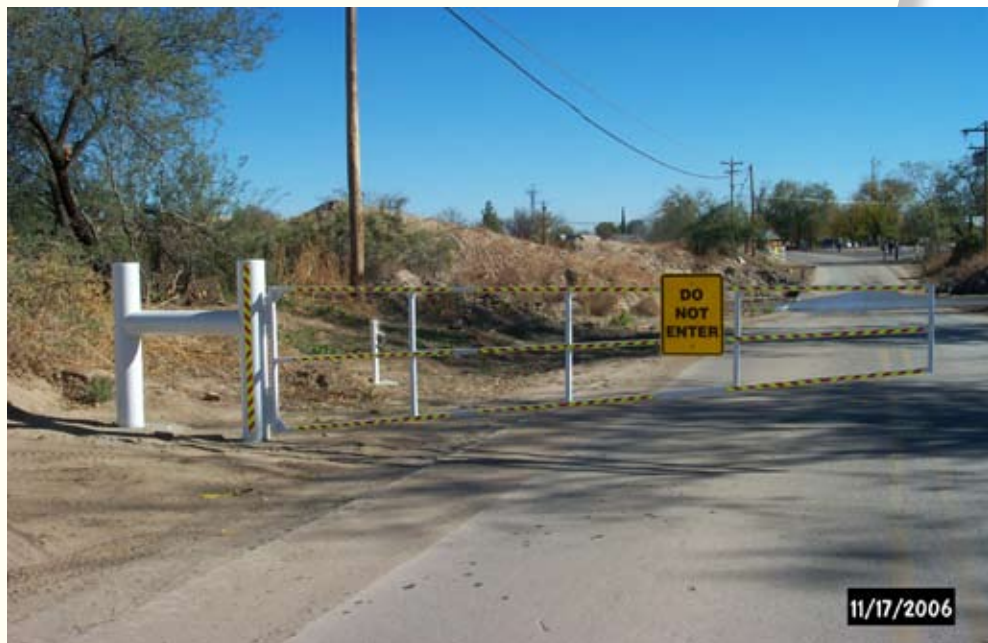
After

The intent of the project is to design and construct barrier gates at the east and west entrances of the crossing. The gates will be closed by emergency personnel or Town staff, to prevent citizens from attempting to cross during flooding conditions. The gate locations are selected to be as close to the outer limits of the 100-year floodplain as possible, while still preventing access to the crossing from the main and side roads. From a vehicular access barrier perspective, the protection offered by the gates is considered to be full 100-year protection since the flooding depths and velocities at the floodplain fringe would typically not pose any significant threat to a motorist parked next to the gate.
